Technical Report

R 857

December 1977

**CORROSION PROTECTION OF EXISTING UTILITY
LINES UNDER PIERS AND WHARVES - RESULTS OF
3 YEARS OF MARINE ATMOSPHERIC EXPOSURE**

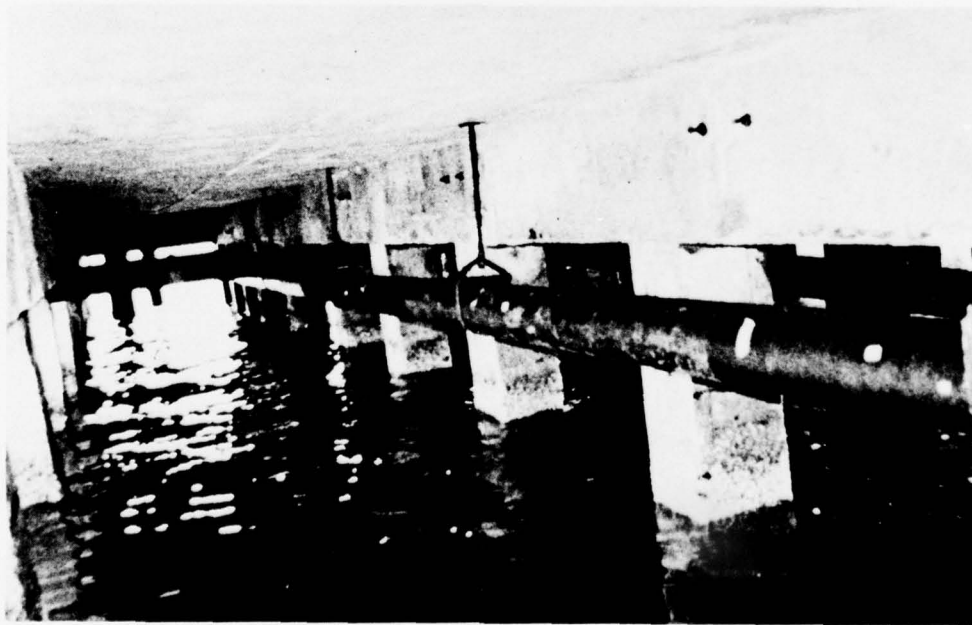
Coating Application. Five coatings (MIL-P-24441, Astrol RP Extra, Rust-Ban EX6692, Carbomastic X2256, and Poly-mastic #455) and two tapes (Denso and Plicoflex) were applied on the wire-brushed fuel lines. All coatings and tapes were applied on the designated areas according to the direction given by each supplier. Each coating or tape was applied on 20-ft (6.1-m) sections of the pipelines (Figure 2). All paints were applied without much difficulty.

Figure 2. Coated fuel lines undergoing field testing at Pearl Harbor.

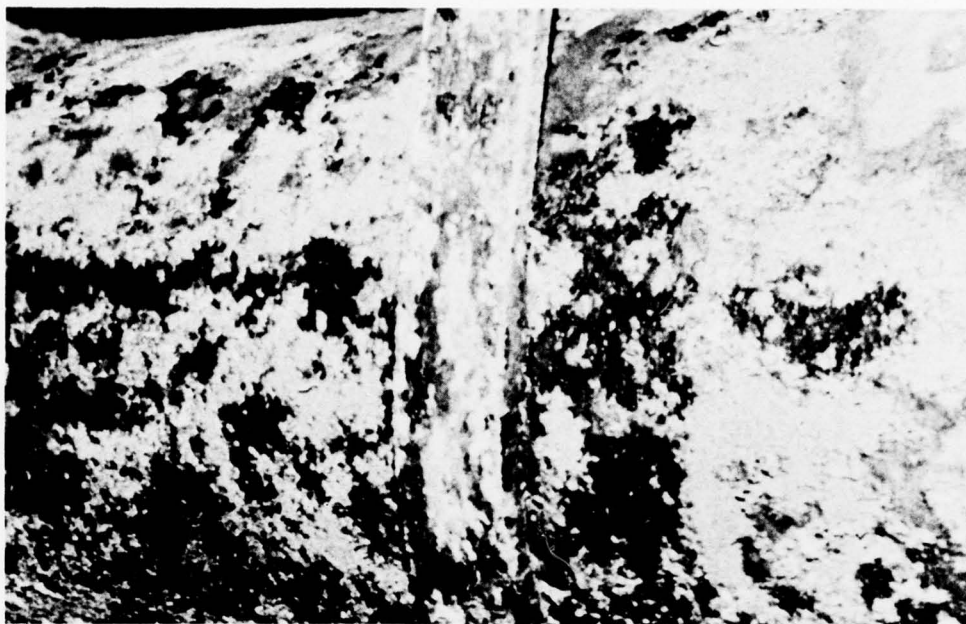
Figure 7. Astro RP Extra coated fuel line after 2-1/2 yr of exposure at Pearl Harbor.

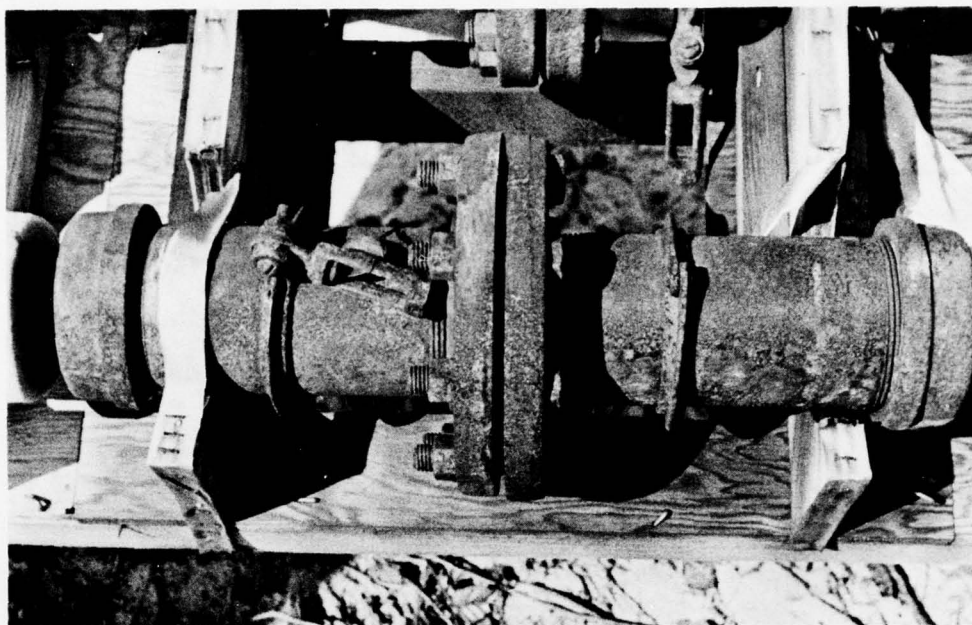
Kwajalein. The original coating on the pipe specimens (Figure 8) was completely gone after 6 mo of atmospheric exposure at Kwajalein (Figure 9). The specimens continued to corrode for the remaining 3 yr of exposure, and the coating offered very little protection. Overall performance of the Astro RP Extra was rated poor during the 3 yr of exposure at Kwajalein.

Figure 9. Astro RP Extra coated pipe specimen after 6 mo of exposure at Kwajalein.

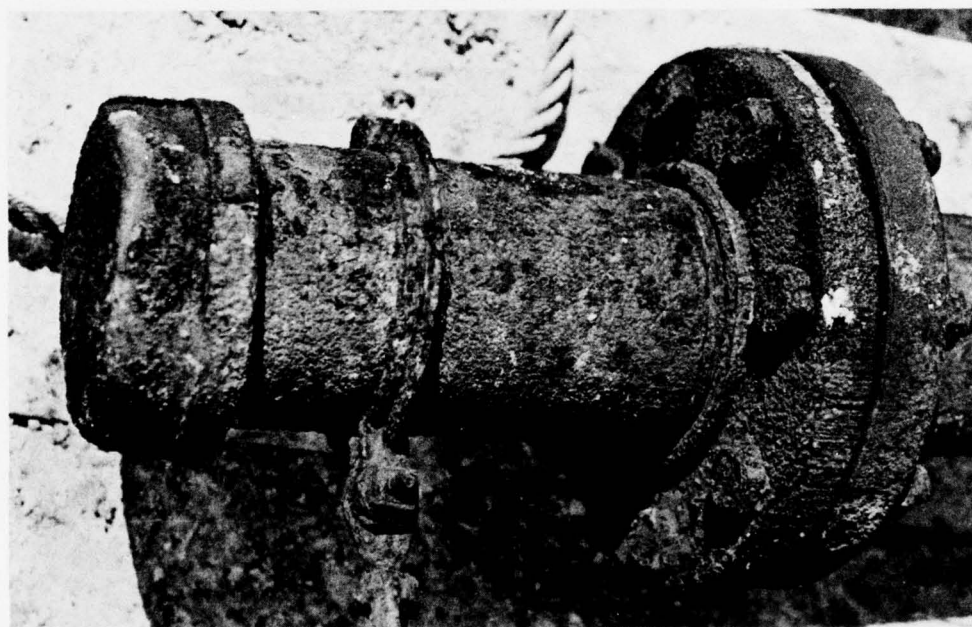
Port Hueneme. The coated pipe specimen suspended from the corrosion dock above the high-tide water level lost its glossy appearance after 6 mo of exposure. Thereafter, the coating rapidly eroded; rust was very much apparent after 12 mo of exposure. By the end of 3 yr of exposure, the coating was completely eroded, and the exposed metal surface was rusted and heavily pitted (Figure 10).

Figure 10. Rusty and heavily pitted pipe specimen coated with Astro RP Extra after 3 yr of exposure above the tidal zone.

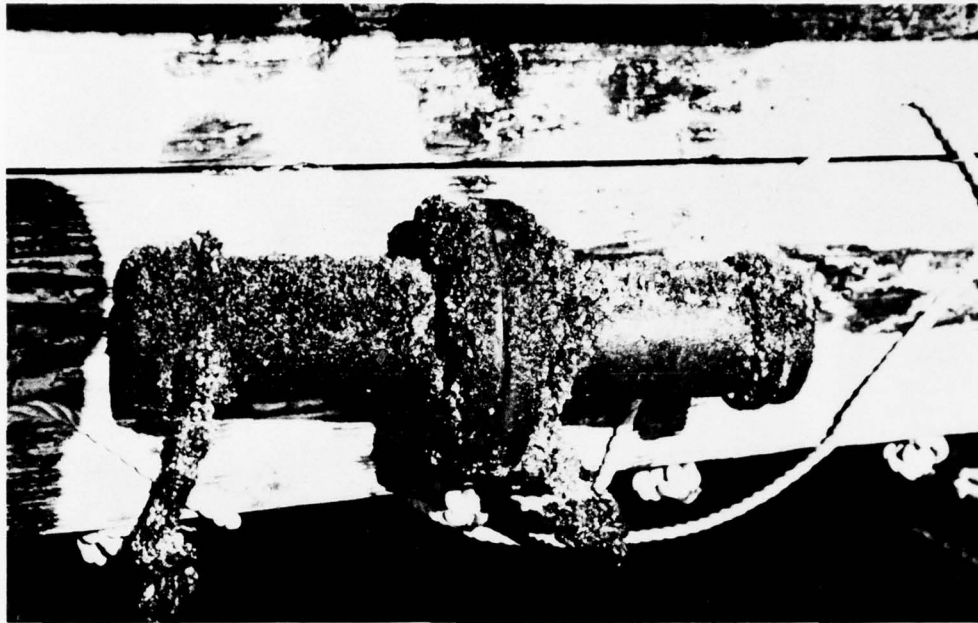
The coating on the specimen suspended within the intertidal zone discolored to a milky color during the first month of exposure because of the seawater absorbed by the coating during submersion. No barnacle growth appeared on the specimen during the first month of exposure, but approximately 25% of the coated surface was covered with red rust. By the end of 12 mo of exposure, the specimen was completely covered with red rust and barnacles (Figure 11). The coating offered very little protection against corrosion, and the condition of the specimen worsened throughout the remaining 3 yr of exposure. Overall performance of the Astro RP Extra was rated poor, both above and below the high-tide zone, after 3 yr of exposure at Port Hueneme.

Figure 11. Rust and barnacles on a pipe specimen coated with Astro RP Extra after 12 mo of exposure below tidal zone.

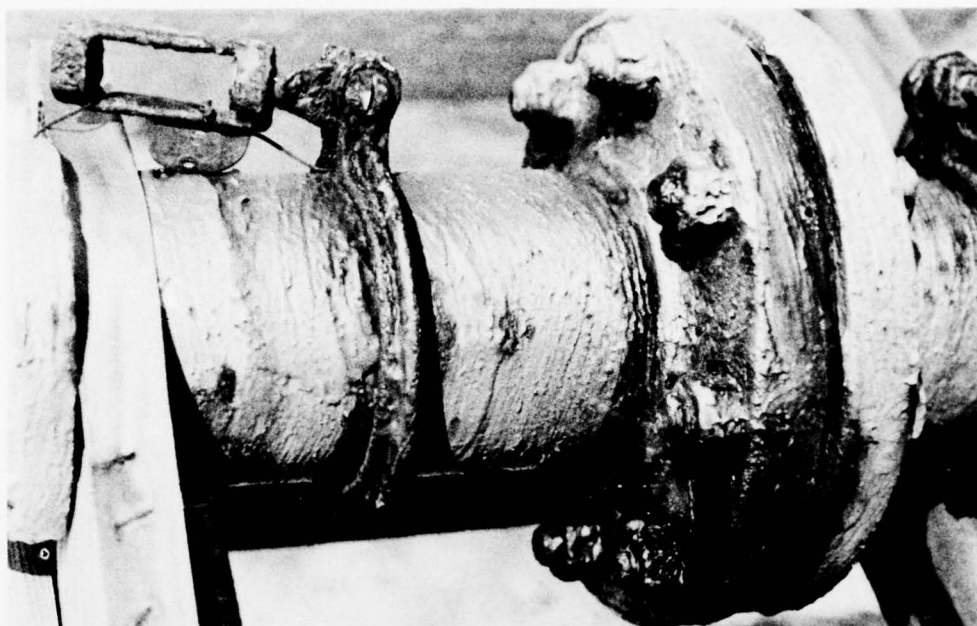
Kwajalein. The Carbomastic X2256-138-coated specimens (Figure 14) began to show rust at irregular surfaces such as bolt heads, nuts, threaded areas, flange joint, and pipe hangers after 6 mo of exposure (Figure 15). The pipe hangers appeared to be particularly vulnerable to the corrosion attack because of the difficulty in obtaining a uniform coating thickness during the coating. Many blisters were found at the flange joint area after 2 yr of exposure. By the end of 3 yr, approximately 50% of the total surface was covered with rust and blisters (Figure 16). The coating showed very little difference in protection between the sandblasted and wire-brushed surfaces. Overall performance of the Carbomastic was rated fair to poor after 3 yr of exposure at Kwajalein.

Figure 15. Carbomastic X2256 coated pipe specimen after 6 mo of atmospheric exposure at Kwajalein.

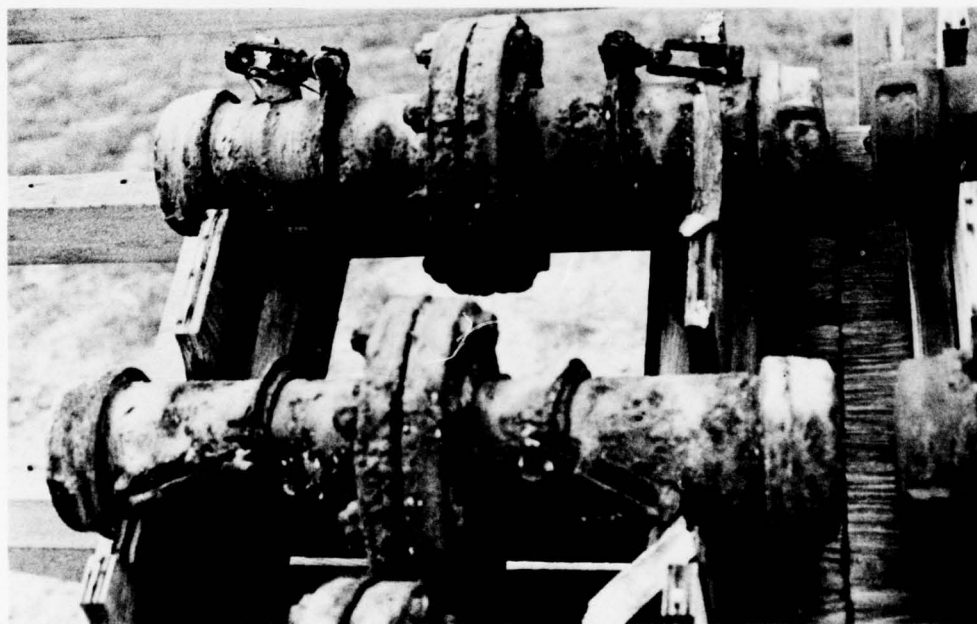
Figure 16. Carbomastic X2256 coated specimens after 3 yr of atmospheric exposure at Kwajalein.

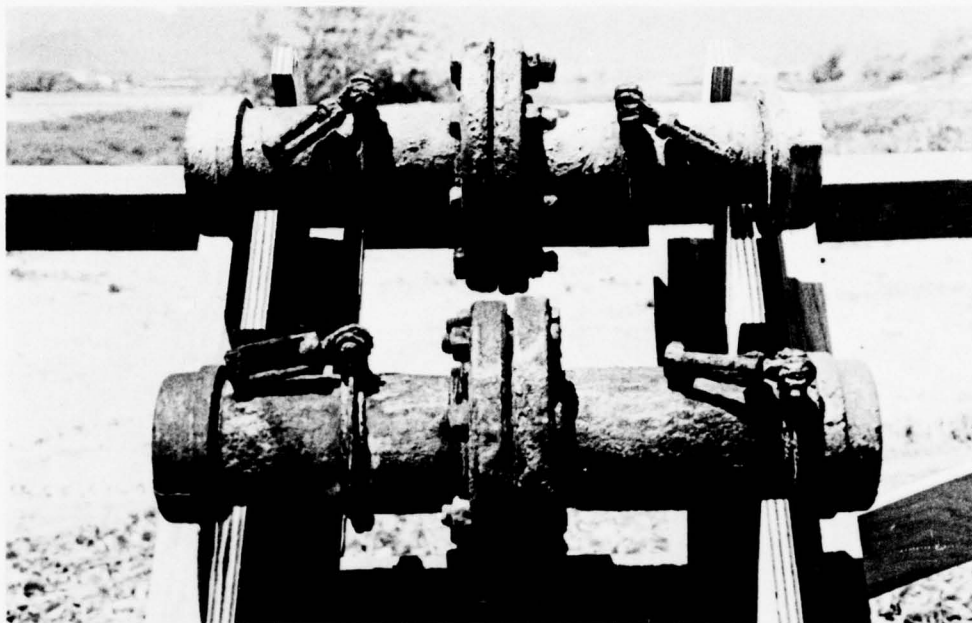
surface. After 3 yr of exposure, approximately 30% of the surface was covered with blisters and rust (Figure 17). Overall performance of the Carbomastic coating was rated fair after 3 yr of exposure at Kaneohe.

Figure 17. Carbomastic (above) and Astro RP (below) coated pipe specimens after 3 yr of exposure at Kaneohe.

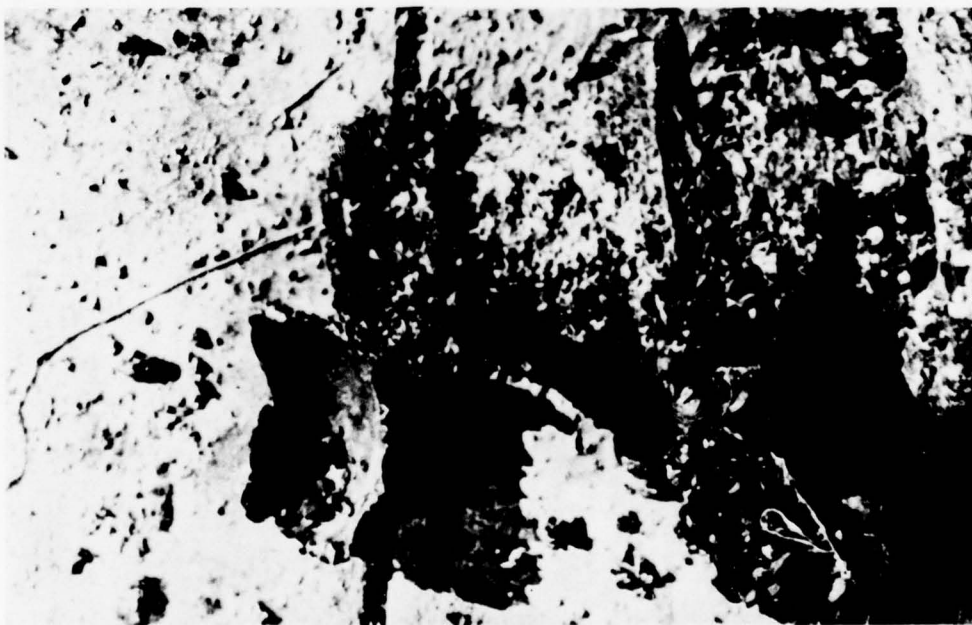
The pipe specimen suspended below the high-tide zone was discolored to brown after 1 mo of exposure, but no rust was noticeable. Barnacles began to grow on it after 6 mo and covered nearly 80% of the surface after 12 mo of exposure. The barnacles continued to grow heavily and damaged and peeled the coating in some areas (Figure 18). Overall performance of this coating was rated poor after 3 yr of exposure below the high-tide zone at Port Hueneme.

Figure 18. Carbomastic coating damaged by barnacle growth after 2-1/2 yr of exposure below tidal zone at Port Hueneme.

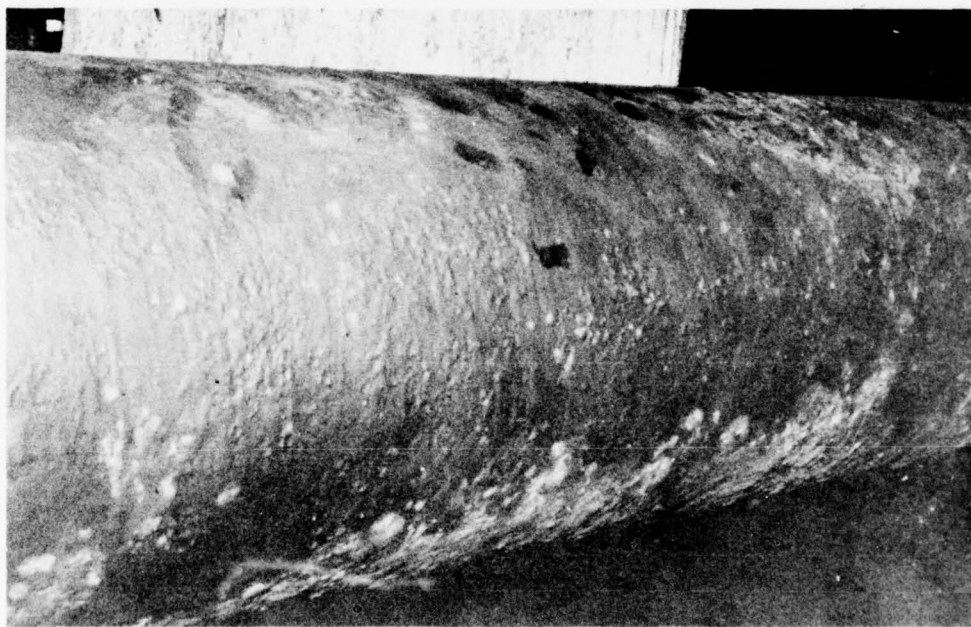
Pearl Harbor. The pipe section coated with Rust-Ban (Figure 19) was protected well during the first 6 mo of exposure. Rust began to appear along the bottom side of the pipeline after 12 mo of exposure. Corrosion along the bottom side of the pipelines appear to be a common problem under piers due to daily condensation of moisture and sea-spray. Upper portions of the coated pipe, however, appeared to be well-protected during 3 yr of exposure (Figure 20).

Figure 20. Rust-Ban after 3 yr of exposure at Pearl Harbor.

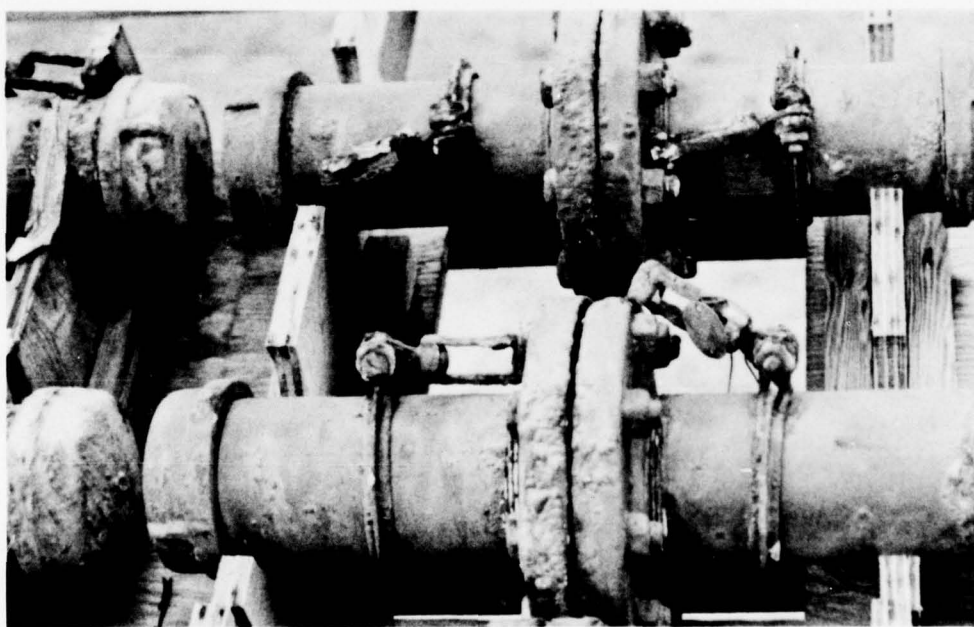
Figure 22. Pipes coated with Rust-Ban exposed for 3 yr at Kwajalein.

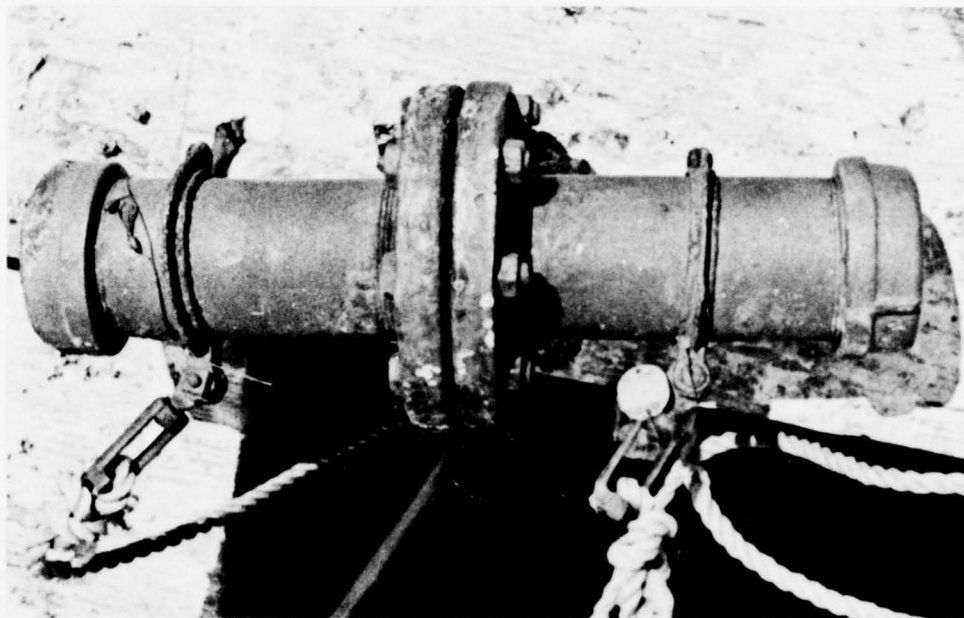
Figure 23. Rust-Ban coated pipe specimen exposed above tidal zone for 3 yr at Port Hueneme.

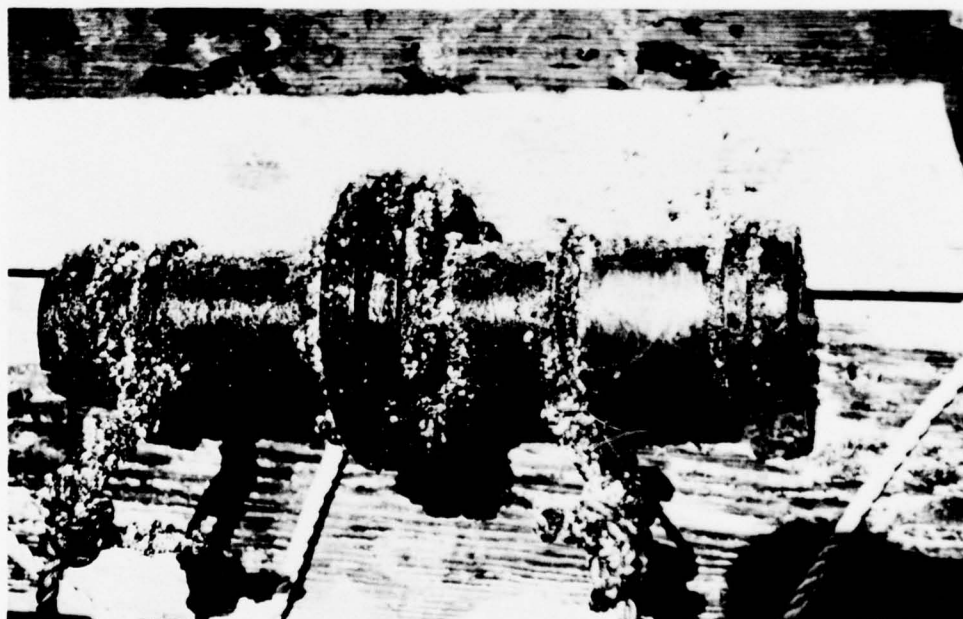
Figure 24. Rust-Ban coated pipe specimen exposed below tidal zone for 12 mo at Port Hueneme.

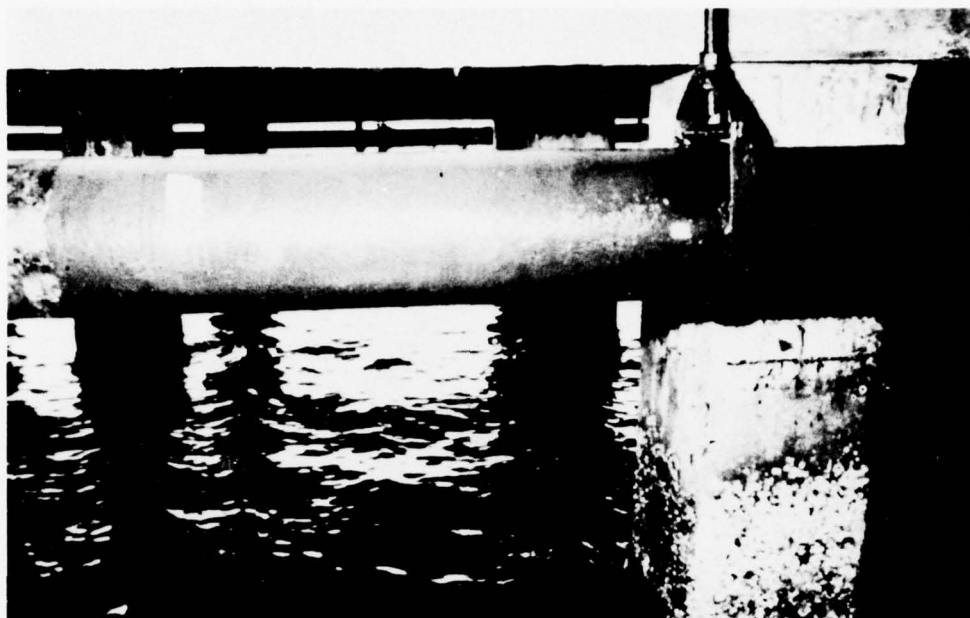
Pearl Harbor. MIL-P-24441, used as a control standard, required a primer and two topcoats (Figure 25). Small localized rust appeared after 12 mo of exposure. Most of the rust appeared where loose rust scales had been incompletely removed or where heavily pitted surfaces prevented even coating. The rust along the bottom of the pipelines due to the daily condensation of moisture and sea-spray was noticed after 2 yr of exposure. However, this coating was providing better protection than other paints undergoing the exposure test (Figure 26). Overall performance of MIL-P-24441 was rated fair to good after 3 yr of exposure at Pearl Harbor.

Figure 25. Fuel line under pier newly coated with MIL-P-24441 at Pearl Harbor.

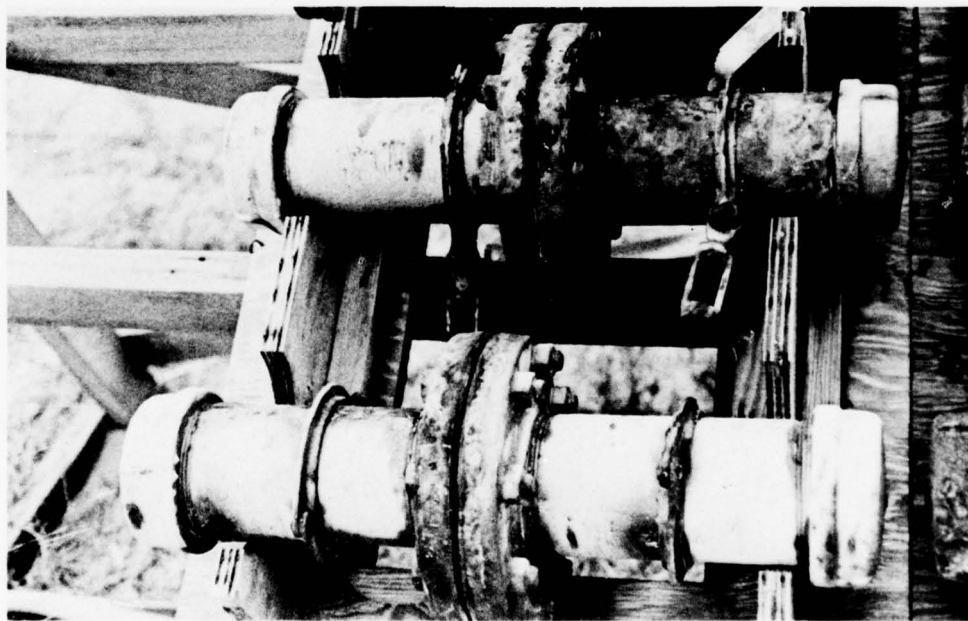
30% to 40% of the surface was covered with rust after 3 yr of exposure (Figure 28). In contrast to other coatings being investigated, MIL-P-24441 appeared to have protected the wire-brushed rusted surface better than the sandblasted surface. Overall performance of the MIL-P-24441 was rated fair to poor after 3 yr of exposure at Kwajalein.

Figure 28. MIL-P-24441 coated pipe samples after 3 yr of exposure at Kwajalein (the pipes on the nut end of the flanges were wire-brushed).

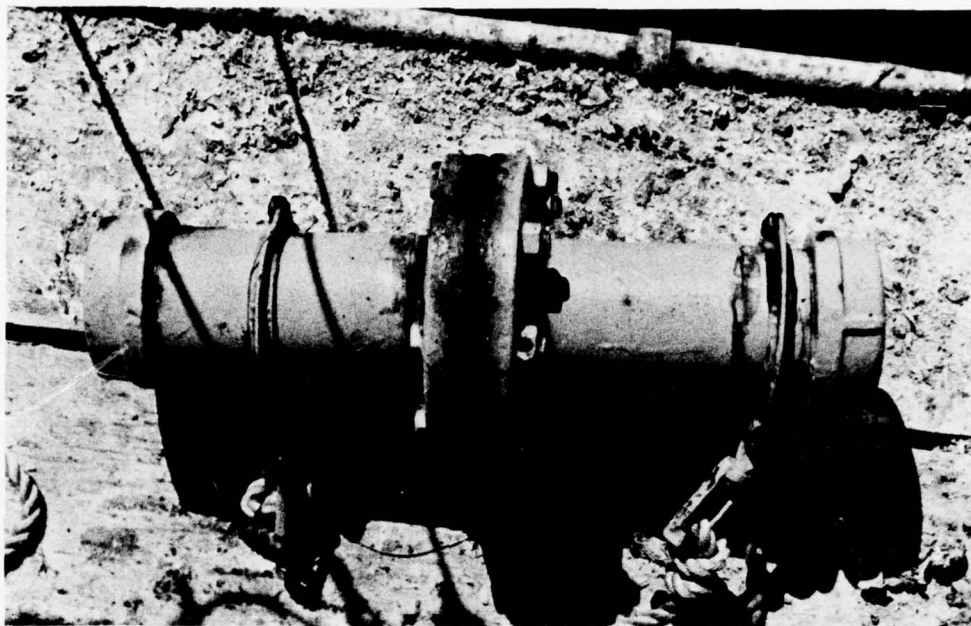
Figure 29. MIL-P-24441 coated pipe exposed for 3 yr above tidal zone at Port Hueneme.

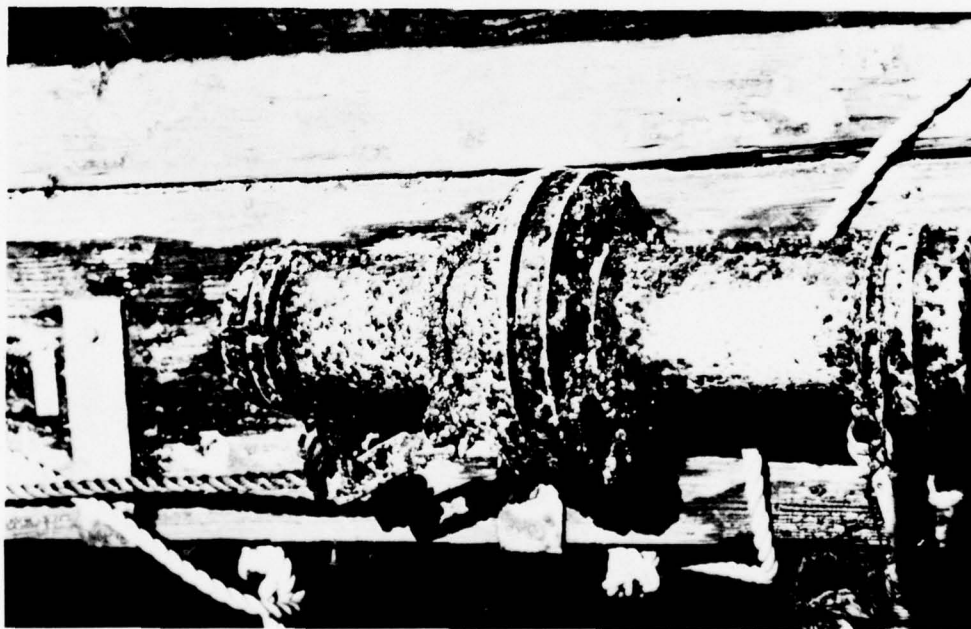
The specimen suspended below the high-tide zone was covered with algae and a slight growth of barnacles after 12 mo of exposure (Figure 30), but there was no noticeable rust. The specimen became heavily covered with barnacles after 2 yr of exposure, but the coating was providing good protection against corrosion. The coating continued to provide good protection for the remaining 3 yr of exposure except where the coating was mechanically abraded during the exposure (Figure 31). Contrary to other coatings being tested, this coating system appears to provide better

Figure 30. MIL-P-24441 coated pipe covered with algae and a few barnacles after 12 mo below tidal zone at Port Hueneme.

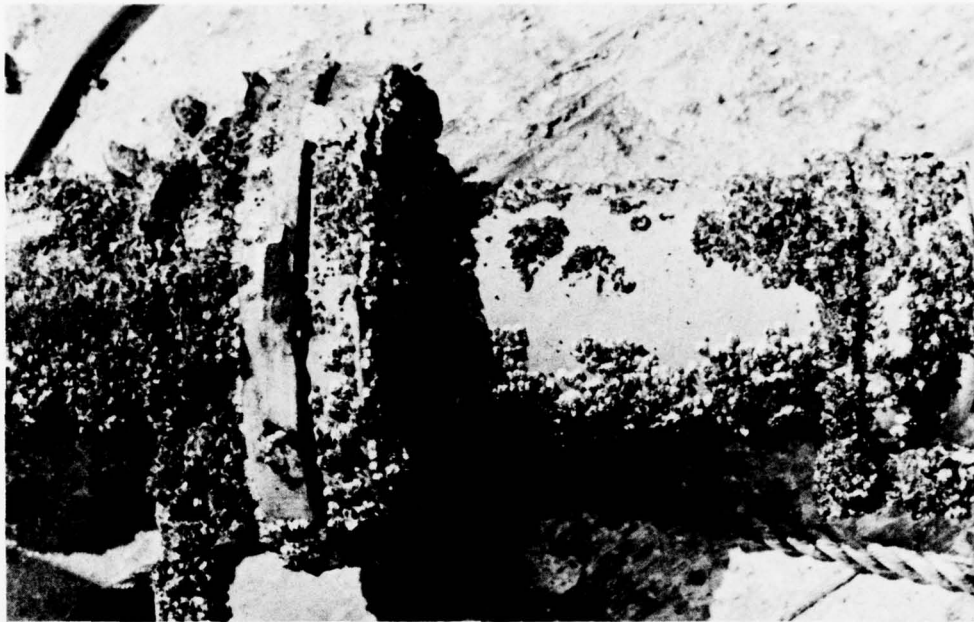
Figure 31. MIL-P-24441 coated specimen exposed for 3 yr below tidal zone at Port Hueneme.

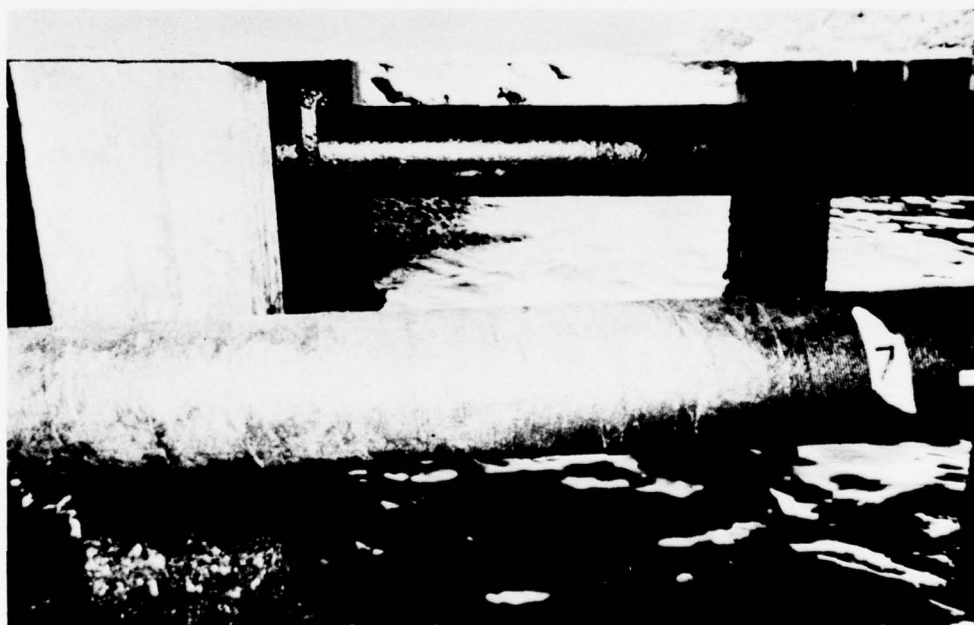
Pearl Harbor. Application of the Denso tape by inexperienced workers appeared to be easier than application of other types of coatings on the pipes. The finished wrapping contained 25% overlap (Figure 32); normally, 50% overlap (double wrapping) is recommended for a marine environment. The tape was adhering well to the pipe, and no loose or detached tape was noticed during the first 12 mo of exposure. A cut was made on the tape to examine the condition of the pipe under the Denso tape. The pipe appeared to be well-protected by the tape system, and no fresh red rust had appeared underneath the tape since its application.

Figure 32. Fuel line under pier with Denso tape applied at Pearl Harbor.

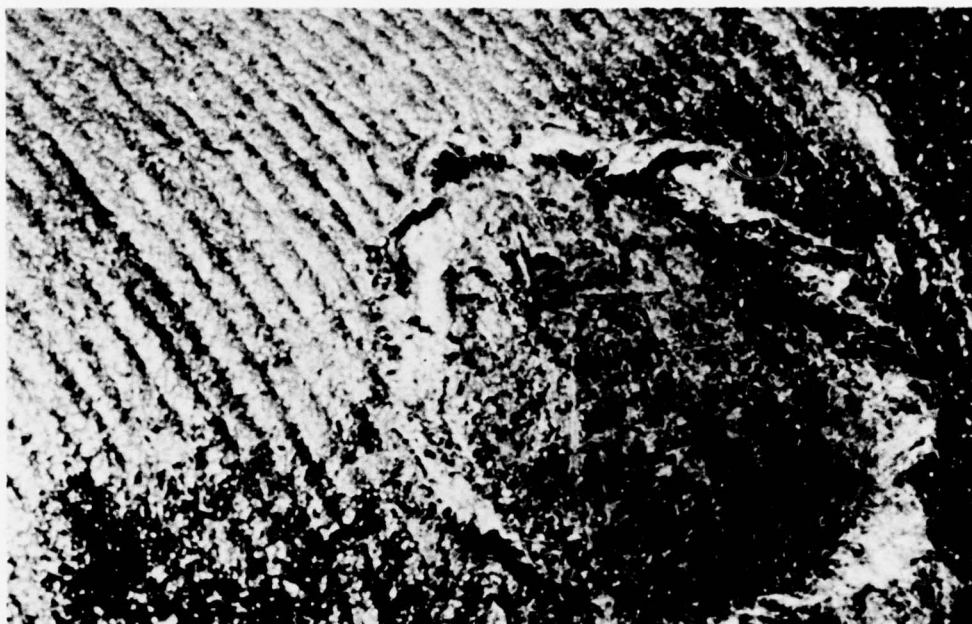
Figure 33. No fresh rust formed under Denso tape after 3 yr of in-field exposure at Pearl Harbor.

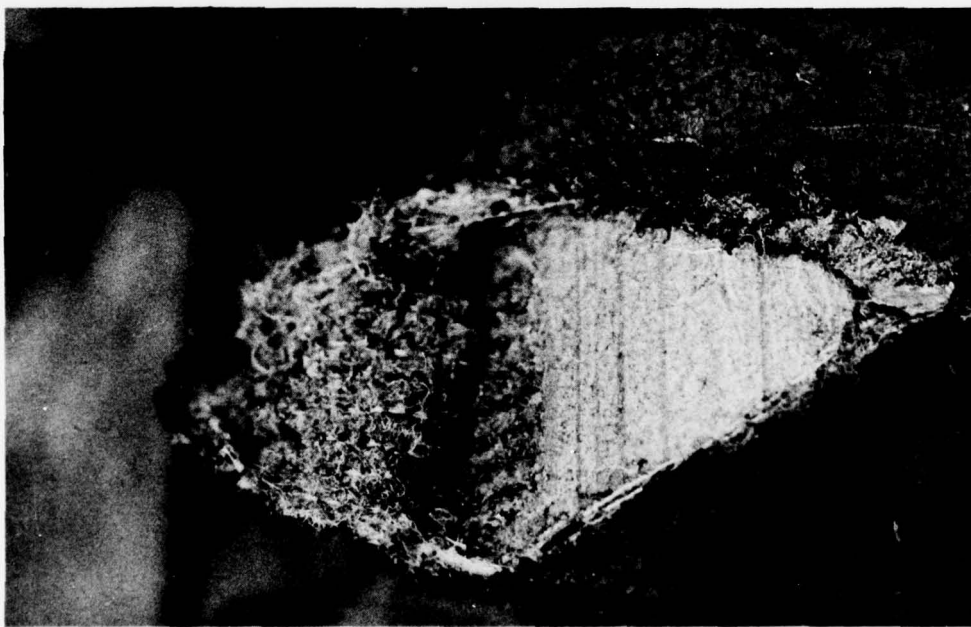
Figure 36. No rust on sandblasted surface under Denso tape after 3 yr of atmospheric exposure at Kwajalein.

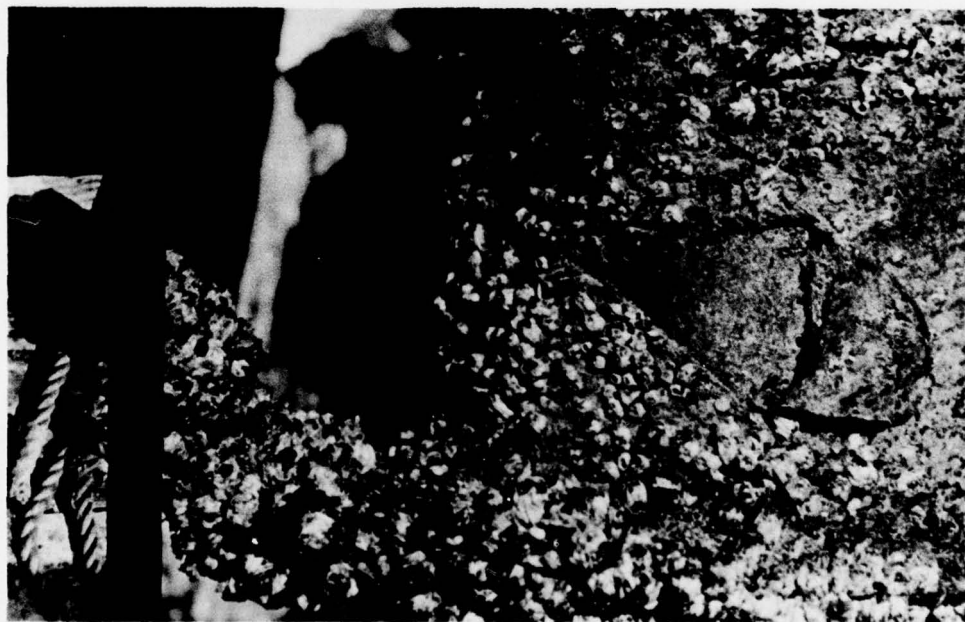
Figure 38. Slight red rust under the Denso tape after 3 yr of exposure below high tide zone at Port Hueneme.

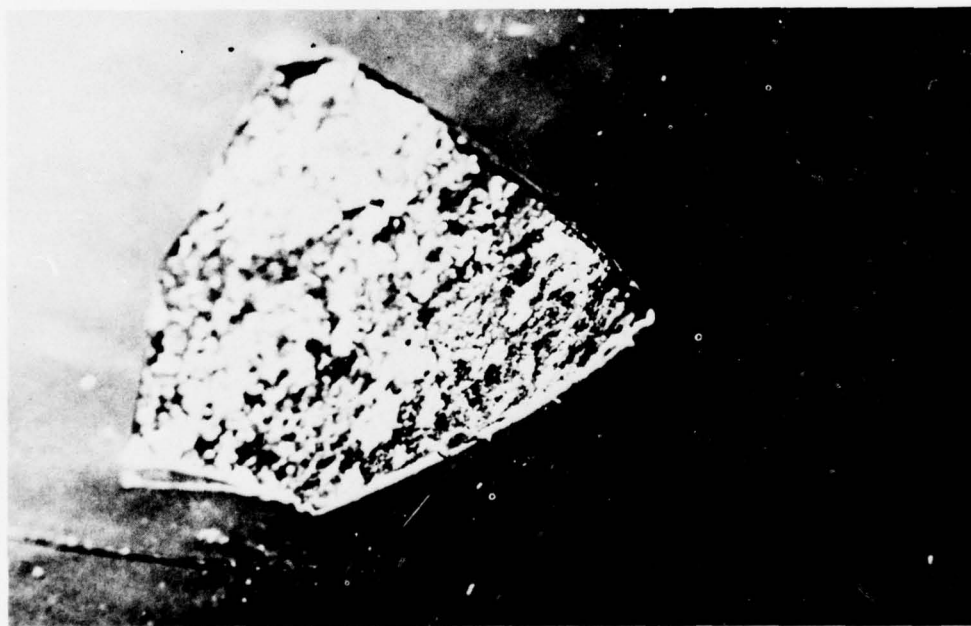
Figure 40. Red rust underneath the Plicoflex tape after 18 mo of exposure at Pearl Harbor.

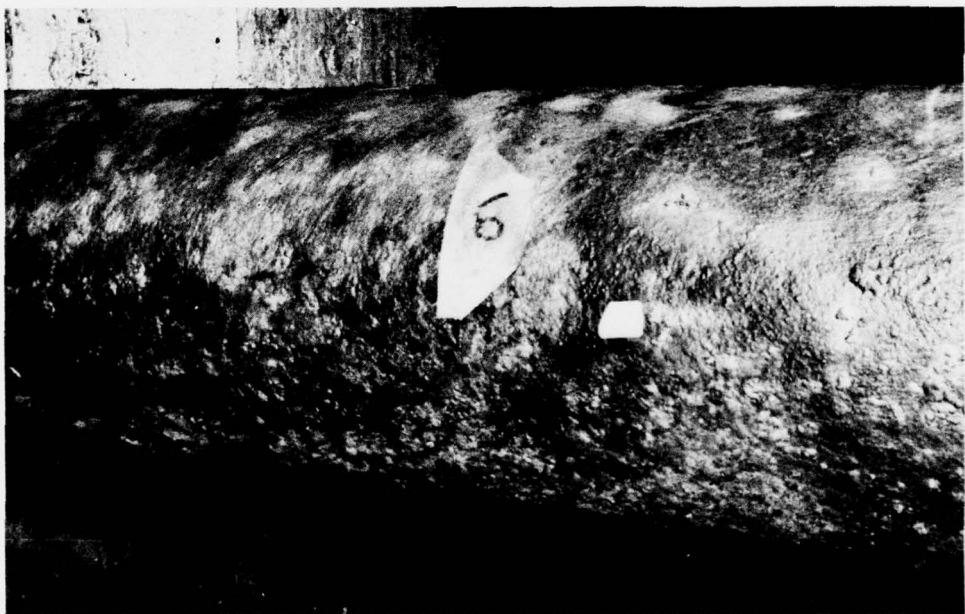
Figure 42. Poly-mastic #455 coated pipe after 3 yr of exposure under pier at Pearl Harbor.

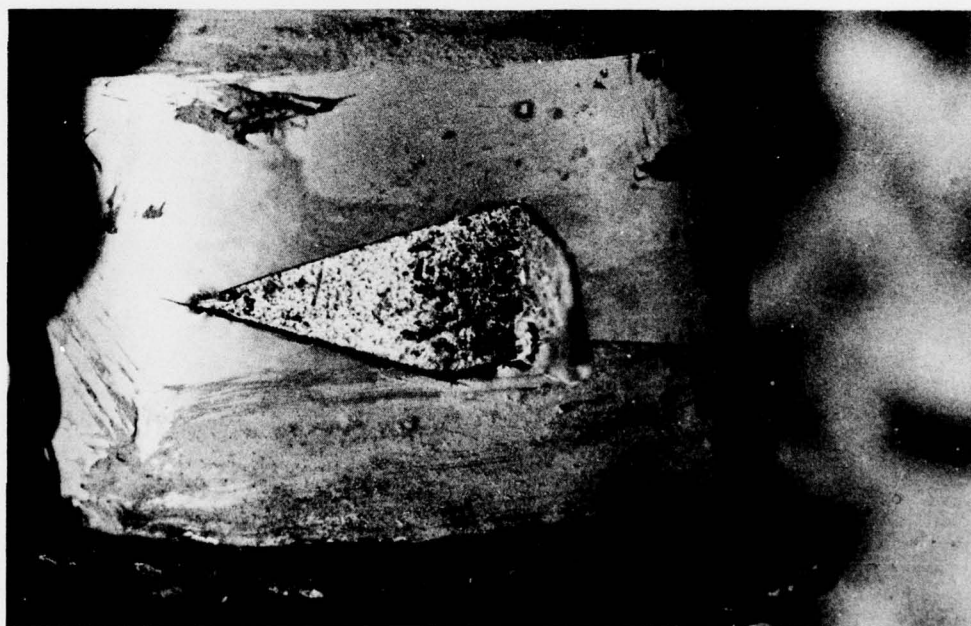
Figure 44. Slight red rust under Plicoflex tape after 18 mo of exposure at Kwajalein.

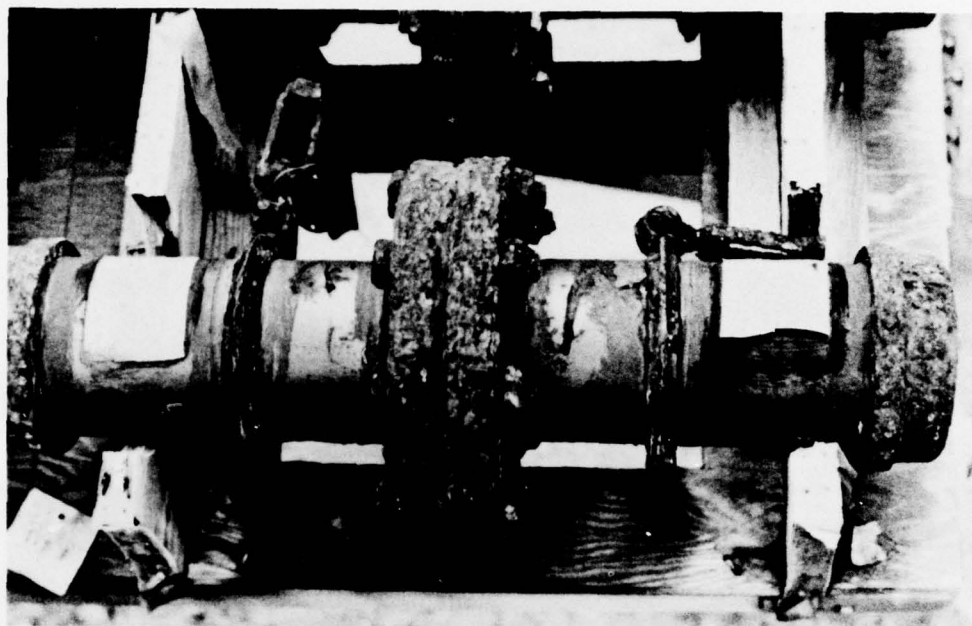
Figure 45. Discoloration and lifting at patched areas after 12 mo of exposure at Kwajalein.

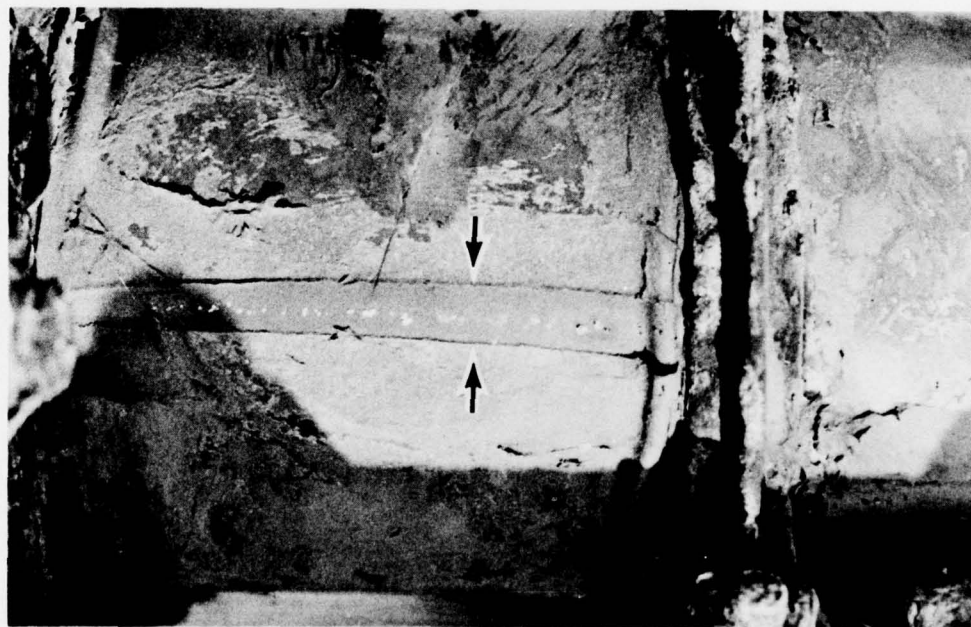
Figure 46. Shrinkage of Plicoflex tape during atmospheric exposure at Kwajalein.

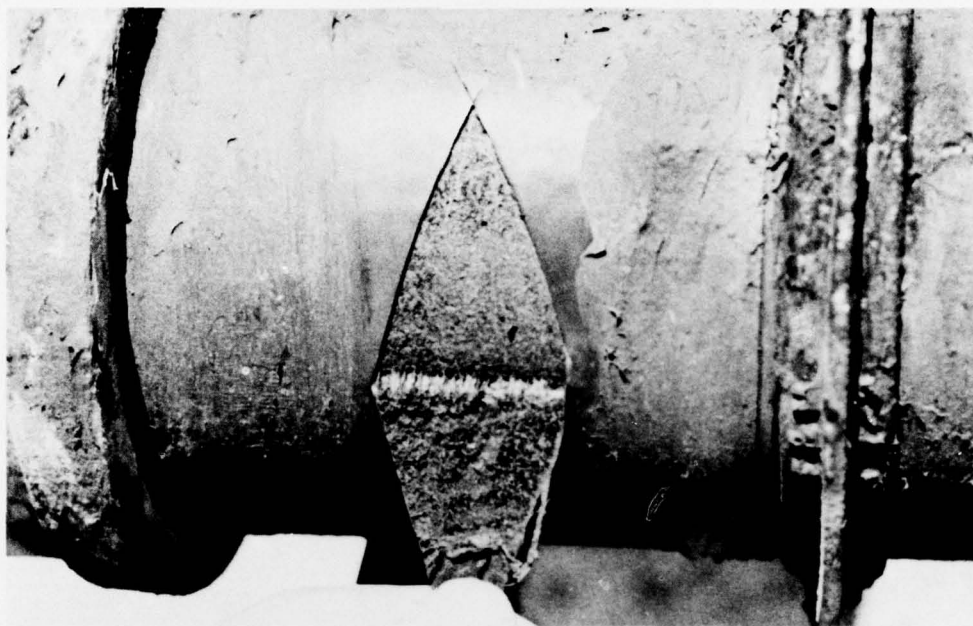
Figure 47. Rust under Plicoflex tape after 12 mo of exposure at Kaneohe.

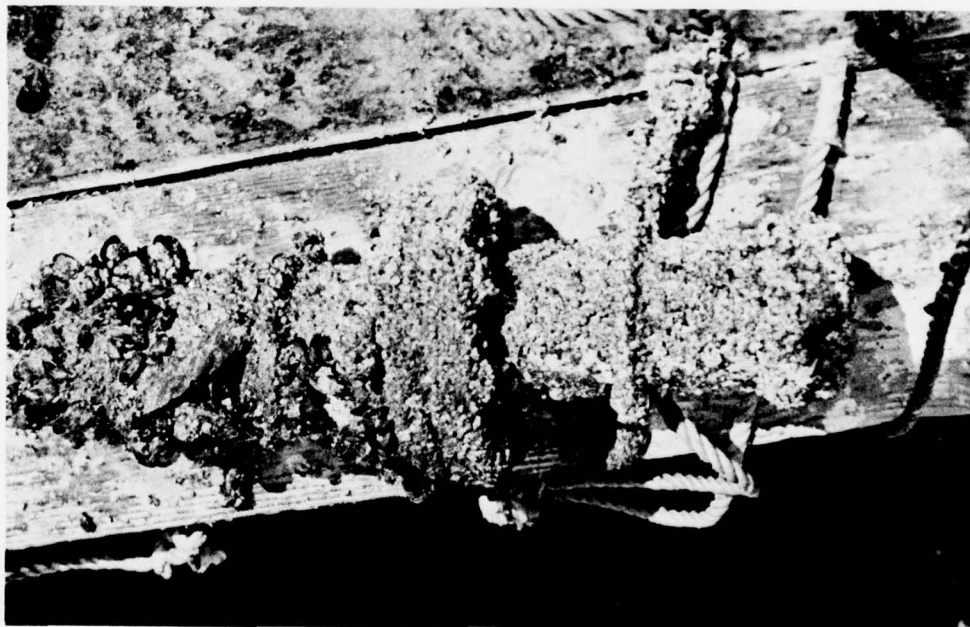
Figure 50. Barnacle growth on PVC tape after 3 yr of exposure below tidal zone at Port Hueneme.

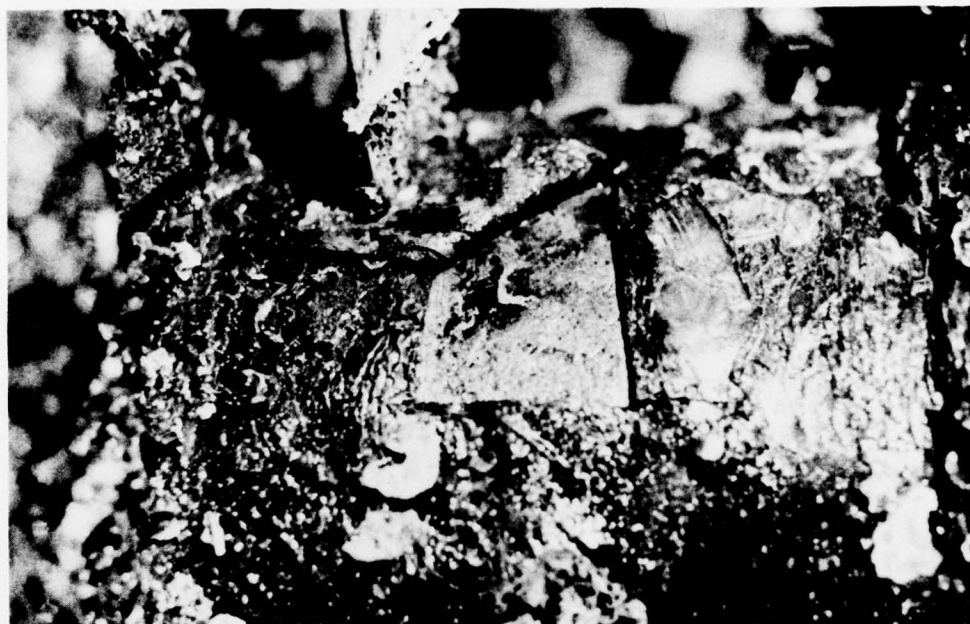
Figure 51. Black oxide under Plicoflex tape exposed for 3 yr below tidal zone at Port Hueneme.

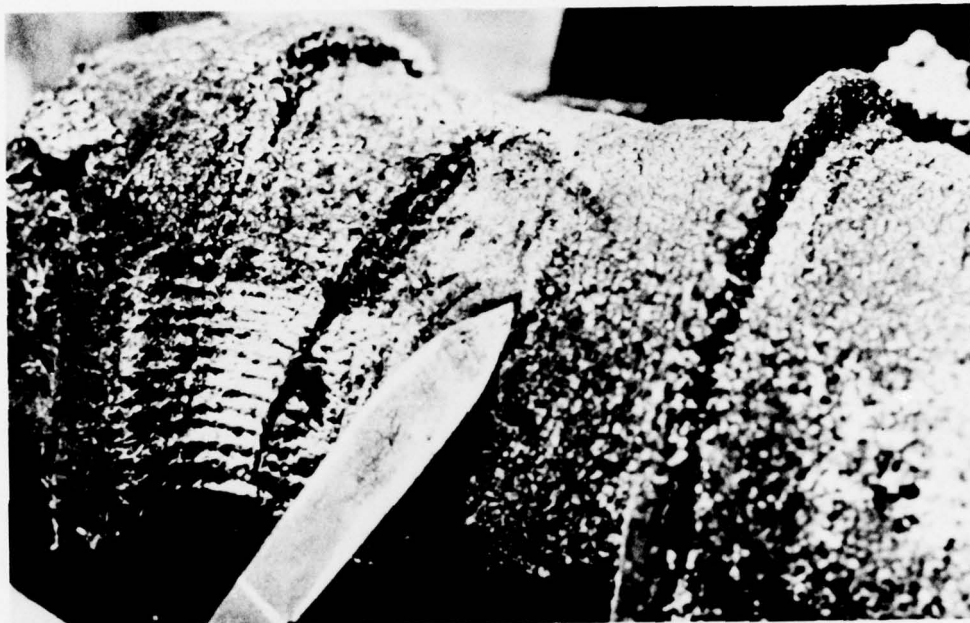
Figure 53. Cut repaired by merely pressing back the peeled tape.
